Bingley Distribution Depot

Asbestos Register

SOTERweb Demonstration

Publication Date: Tuesday 14 March 2023

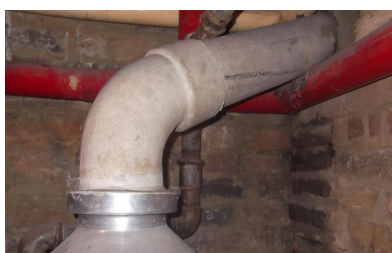
ID	3	Client Ref	621
Room/Area	MB54	Location	To mains gas pipework.
Product	Gaskets	Type	Chrysotile(White)
Condition	Medium Level of Damage	Surface Coating	None
Quantity	2.00	Number	
Action Score	9	Risk Rating	Low Risk
Comments			
Sample Ref	DA002830	Result	Asbestos detected
